Aviation Risk Solutions Inc.Birchwood BCV AirportInspection Report

Inspection date 6/9/2014

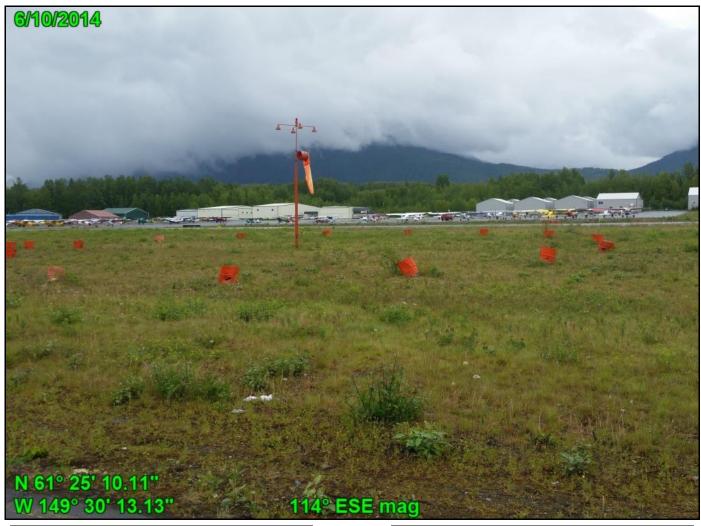
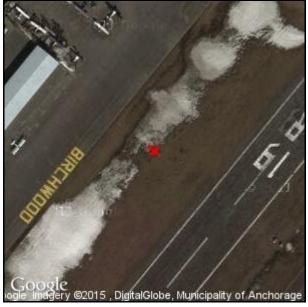
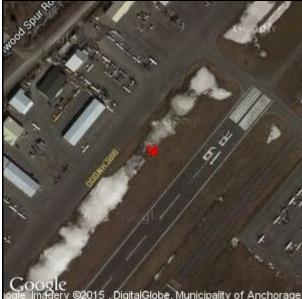
Navaid, windsock midfield, east side of runways

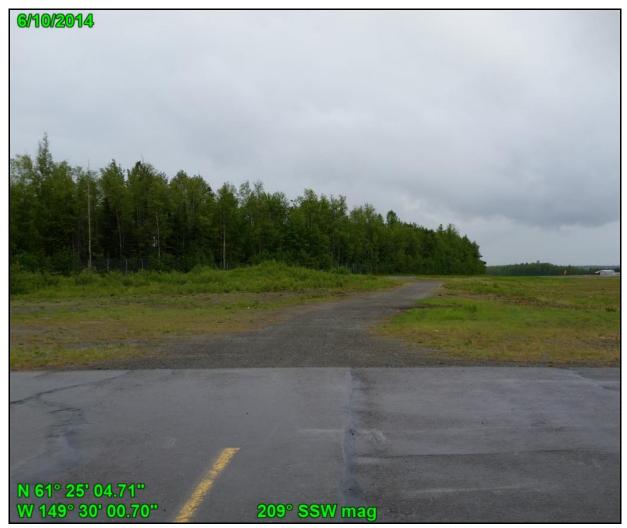
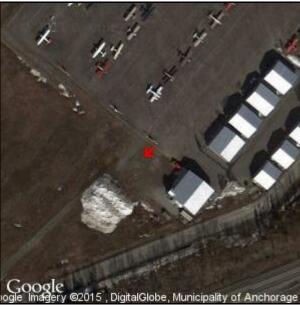
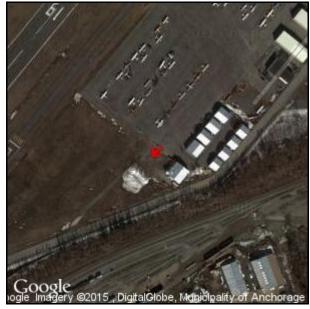
Road access to norh east ramp

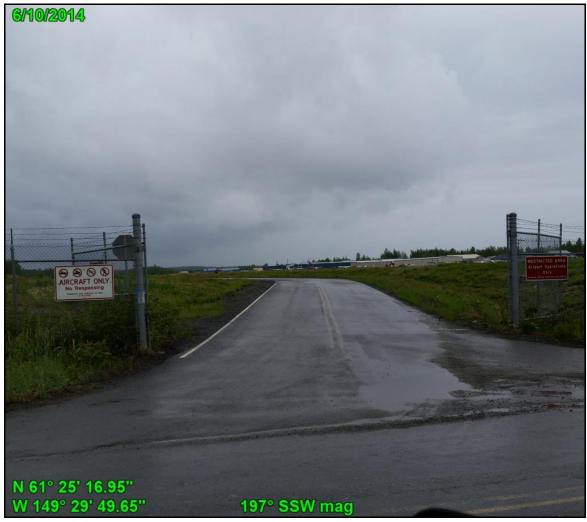
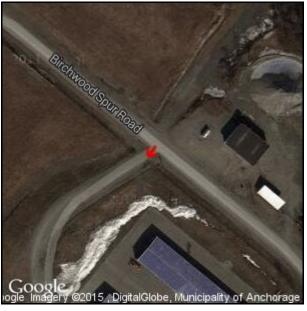
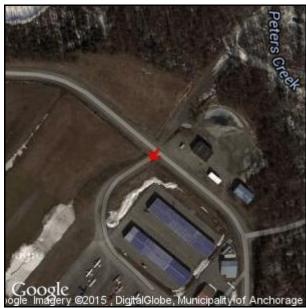
Road access to west ramp

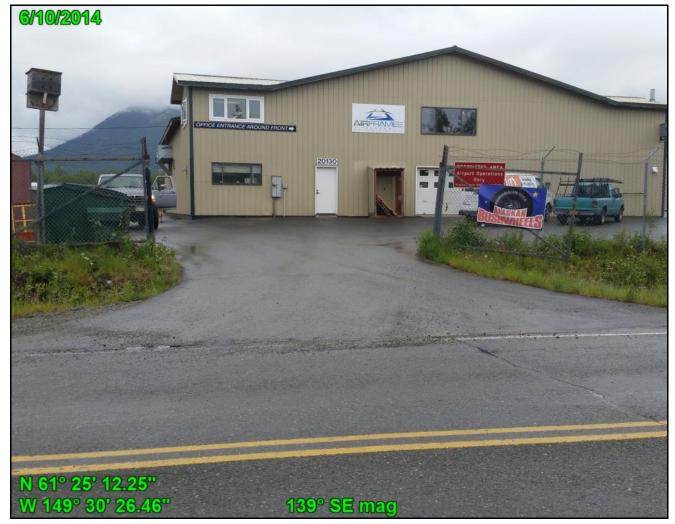
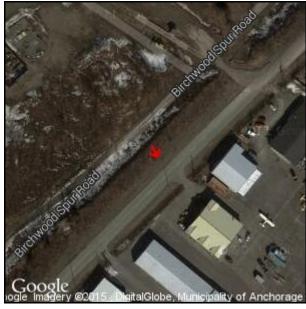
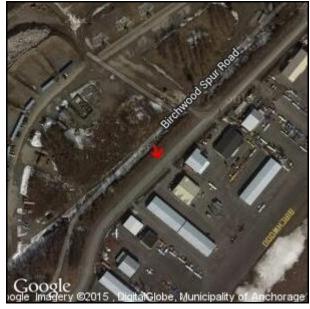
Road access, west ramp

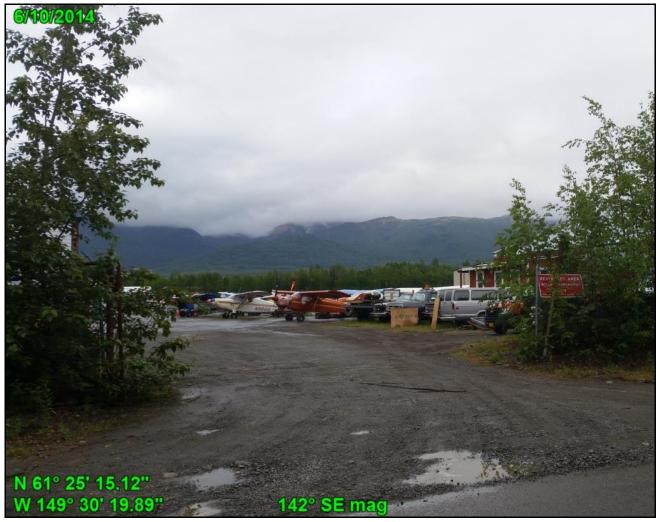
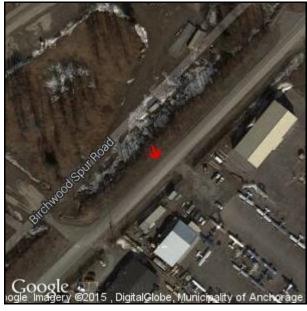
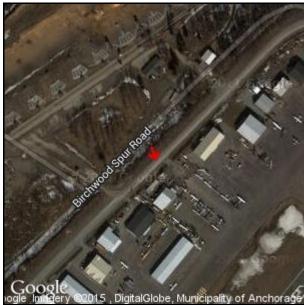
Runway 02L controlling obstruction

02L-21:176' trees 1647' from threshold, on both sides of centerline.

76' trees, 1647' from runway end, on both sides of centerline. Approach slope 20:1

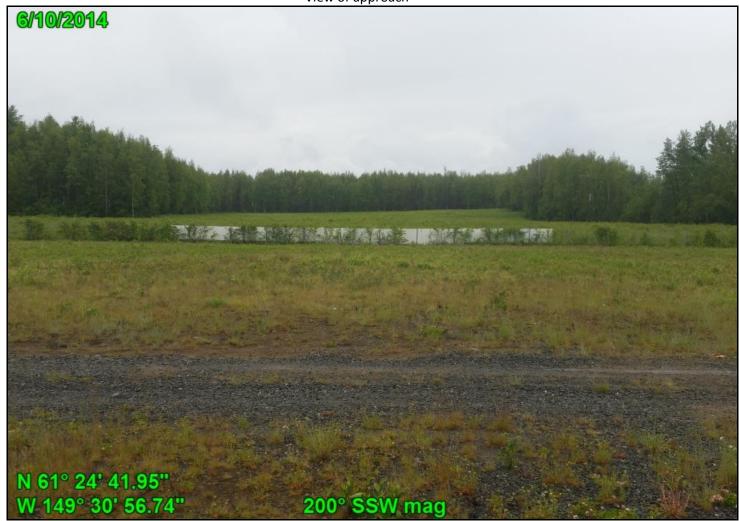
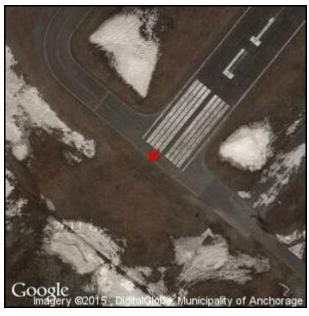
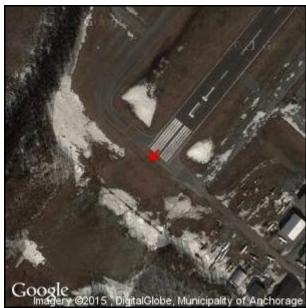
Runway 02R controlling obstruction.

02R-21:1 77' trees 1622' from threshold, 180' right of centerline.

77" trees, 1622' from runway end, 180' right. Approach slope 21:1

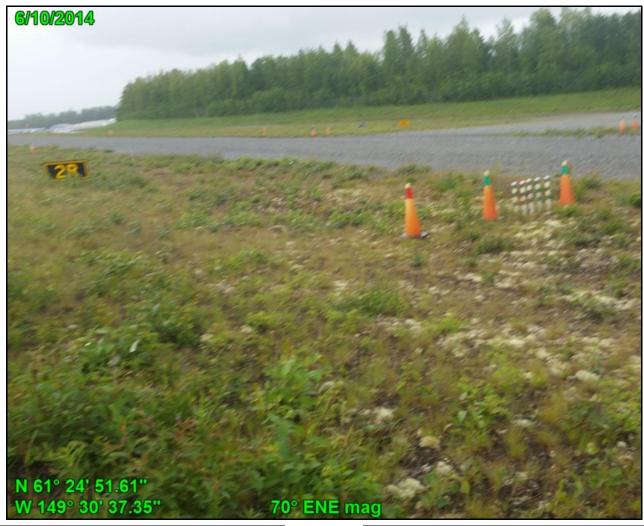
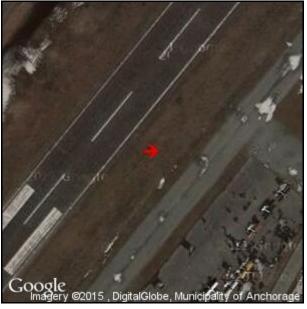
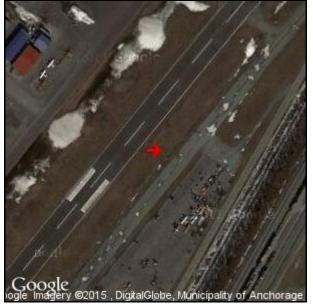
Runway 02R midfield

Asphalt and gravel meet at this point

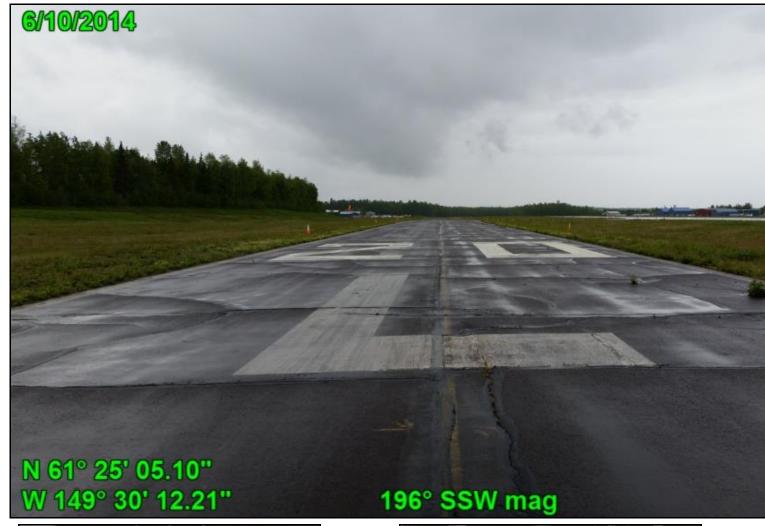
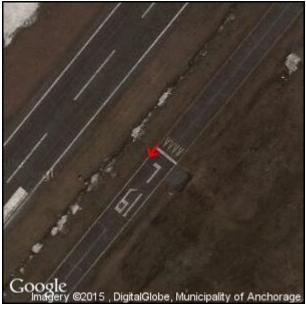
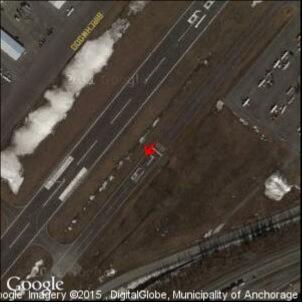
Runway 20L/02R midfield

asphalt and gravel meet at this point.

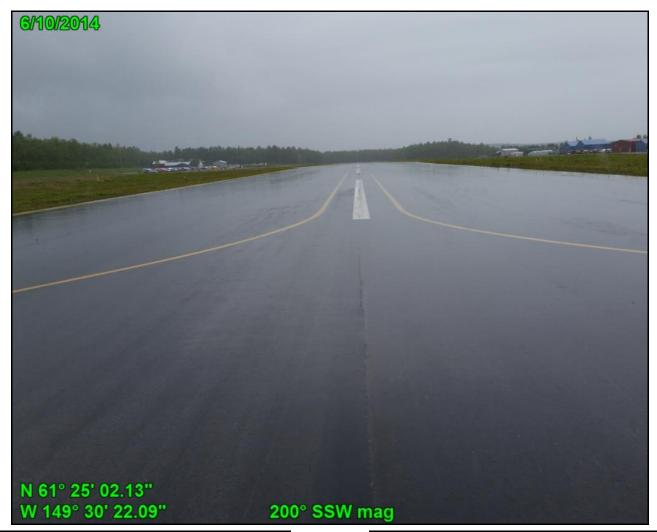
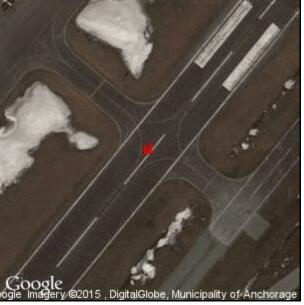
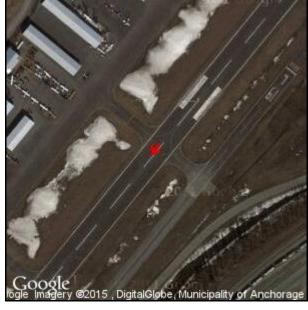
Runway 20R controlling obstruction

20R-20:1 55' trees 1112' from threshold, 120' left and right of centerline.

55' tree, 1112' from runway end, 120' right, approach slope 20:1

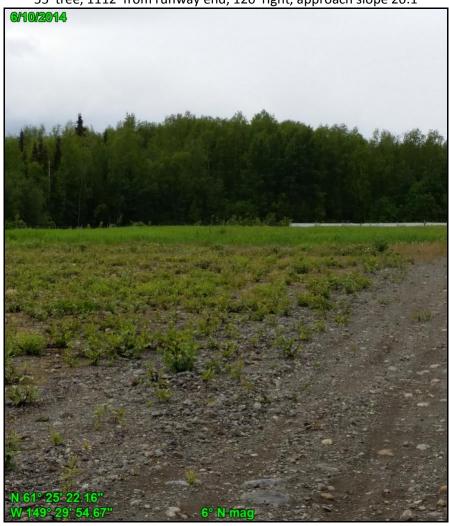
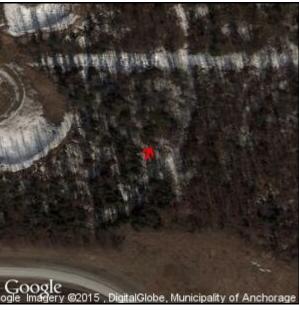
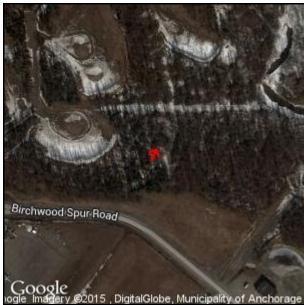
Runway 20R controlling obstruction

55' trees, 1112' from runway end, 120' left. Approach slope 20:1

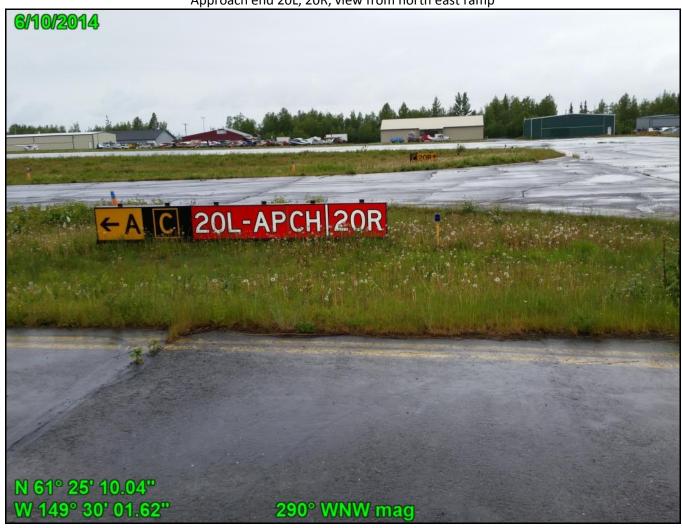
Signage, Approach end 20L, 20R, view from north east ramp

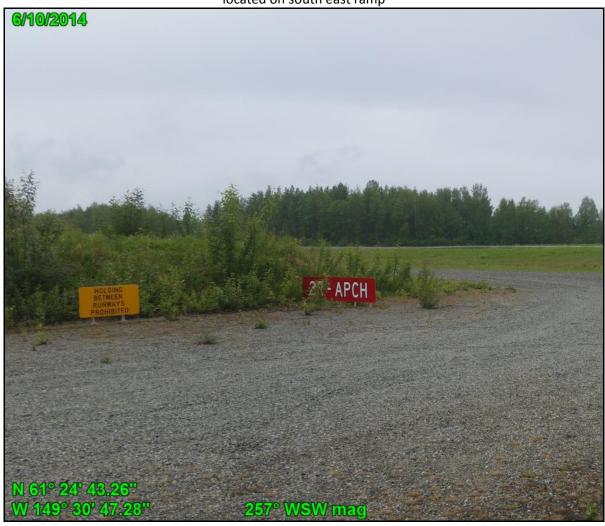
Signage, located on south east ramp
